SMITHSONIAN INSTITUTION
BUREAU OF AMERICAN ETHNOLOGY
BULLETIN 121

ARCHEOLOGICAL REMAINS IN THE
WHITEWATER DISTRICT
EASTERN ARIZONA

PART I. HOUSE TYPES

By FRANK H. H. ROBERTS, JR.

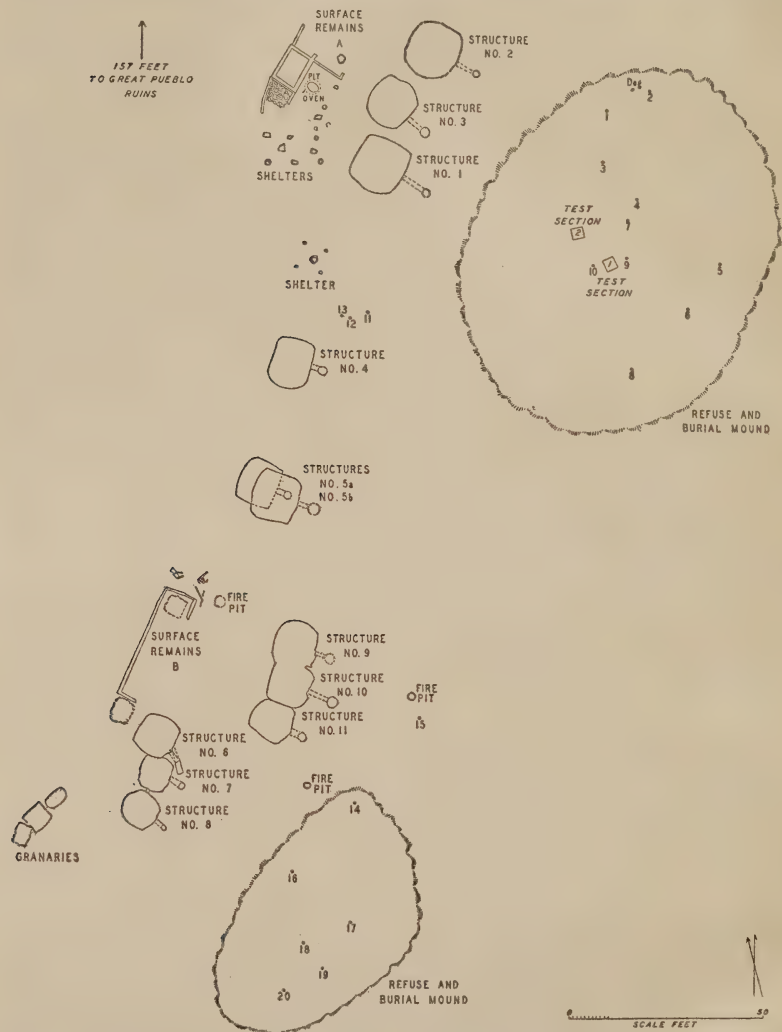
FIGURE 1.—Group 1 pit and surface remains. Numbered dots indicate location of burials.

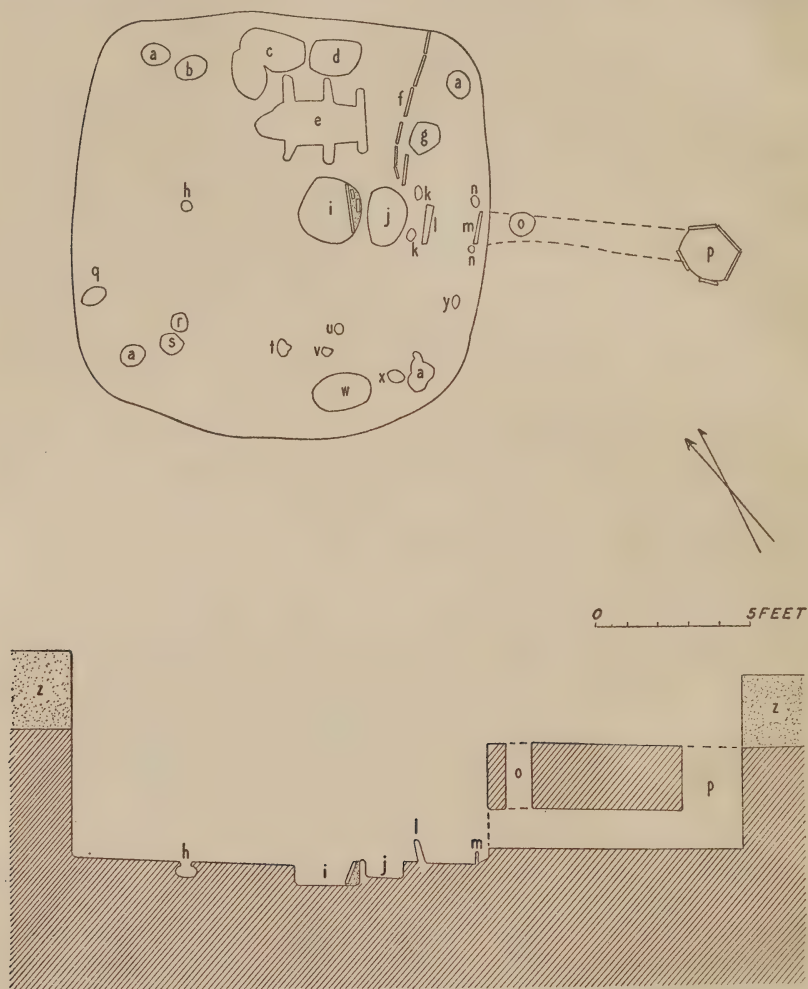
FIGURE 2.—Structure 1. *a*, holes for support posts; *b*, *c*, and *d*, storage basins; *e*, basin in floor; *f*, wall forming compartment; *g*, basin in floor; *h*, sipapu; *i*, fire pit; *j*, ash pit; *k*, ends of ladder poles; *l*, deflector; *m*, stone to protect ventilator opening; *n*, pole placement; *o*, small shaft in ventilator; *p*, main ventilator shaft; *q*, pot rest or storage hole; *r*, *s*, *t*, *u*, *v*, *w*, *x*, and *y*, storage holes and basin; *z*, sand accumulation above old ground level.

The larger basin-like depressions (fig. 2, *c*, *d*, *w*) possibly served as places in which baskets or jars were set, although there was no indication that such had been the case. What function the curiously shaped depression *e* may have been intended to fulfill is a question for which no answer has been found. At the time when the remains were excavated a small pitcher of the culinary variety of pottery was sitting in the end toward the ventilator side of the room. Several who saw the house suggested that loom sticks may have been placed across the depression in the arm-like projections at each side of the central portion. In view of weaving practices in general, as they are known throughout the Southwest, this does not seem to be a good explanation. There was nothing about the depression itself to furnish a clue.

The hole marked *h*, figure 2, corresponds in its general size and position to similar ones found in most pit houses and in many present-day kivas. In the kivas or ceremonial chambers the feature is called the sipapu, because the modern Pueblos use that name or a close variation of it to designate the hole. According to them it symbolizes the mythical place of emergence through which their ancestors are supposed to have passed in their journey from the inner portions of the earth, where they were created, to the surface of the world upon which they now live. Whether a similar interpretation was made in the past or not is a matter of conjecture. The belief is so firmly implanted in Pueblo mythology, however, that it may with considerable justification be assumed that the prehistoric people regarded the feature in the same light. A further support for this theory is derived from

seven stones forming a bin-like enclosure at the southeast corner of the room (fig. 2, *f*; pl. 3, *a*). One of the typical interior elements in Modified Basket Maker houses consists of a low wall of stone slabs separating the ventilator or, as was the case in many of the dwellings of that period, the entrance side of the chamber from the rest of the room. Sometimes the partition wall extended entirely across from support post to support post. Then again it was broken by a doorway in front of the passage opening into the wall. Occasionally a house is found that only has corner bins at that side of the room.²⁰ The enclosure in one corner of No. 1 is very suggestive of the more complete examples found in the Chaco Canyon houses and possibly represents a survival in the houses of a later day of a characteristic common during a previous stage in house development. The purpose of such compartments is not known. Two metates or grinding stones were found in the present example. This would suggest that the enclosure may have served as a mealing bin for the house. On the other hand it is quite possible that the stones were placed there during intervals when they were not in use, since one was leaning against the partition and the other against the wall. The bin may have served solely in the capacity of a storage place. Firewood, jars containing surplus food and other items connected with the daily life of the people could have been placed there where they would not interfere with the general trend of affairs in the main part of the structure. Somewhat comparable enclosures in the earth lodges of some of the Plains Indians, dwellings which in many ways bear a strong resemblance to the pit houses of the Southwest, despite the fact that they were largely surface structures, were employed for storing the supply of firewood in winter.²¹

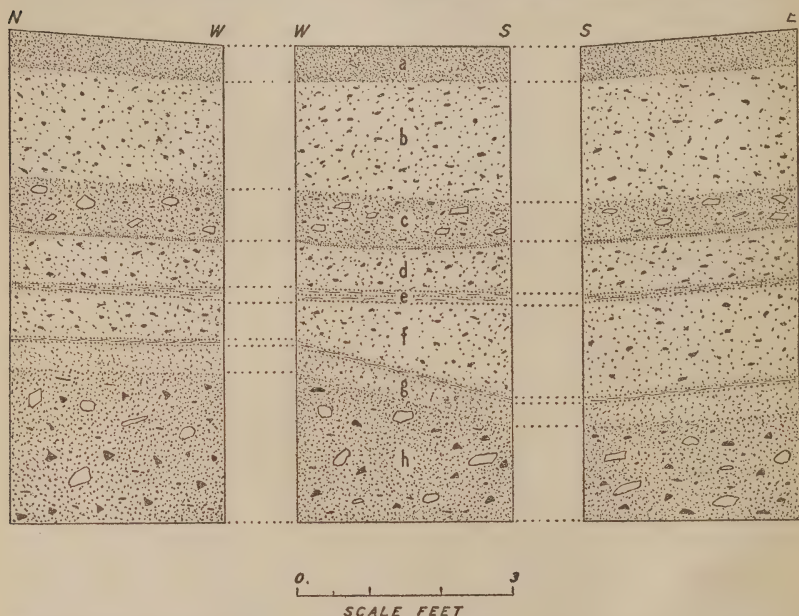
FIGURE 3.—Pillar left from fill in structure 1. N, W, S, and E, indicate north, west, south, and east corners. *a* to *h*, Strata in fill.

The second stratum (fig. 3, *b*) was considerably thicker than the first. It was 1 foot 6 inches (45.72 cm) from top to bottom. The main content was blow sand and ashes with some charcoal. Toward the lower half there was a marked increase in the number of potsherds present. In fact there was only one other layer in the entire pillar which contained more. This would suggest that there was considerable activity around the site at that time and the remains of many broken vessels found their way into the abandoned pit. The stratum did not give distinct evidence at this point of having typical refuse material in it and it does not seem that it can be attributed to house sweepings and other waste matter being dumped there. Rather would the character of the fill at this point suggest a more or less natural gravitation of objects into a depression.

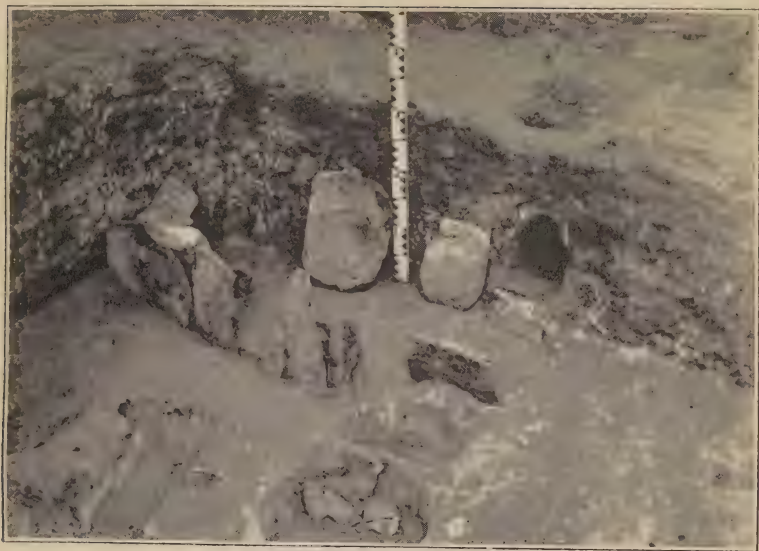
b. Main framework for restoration of structure 1.

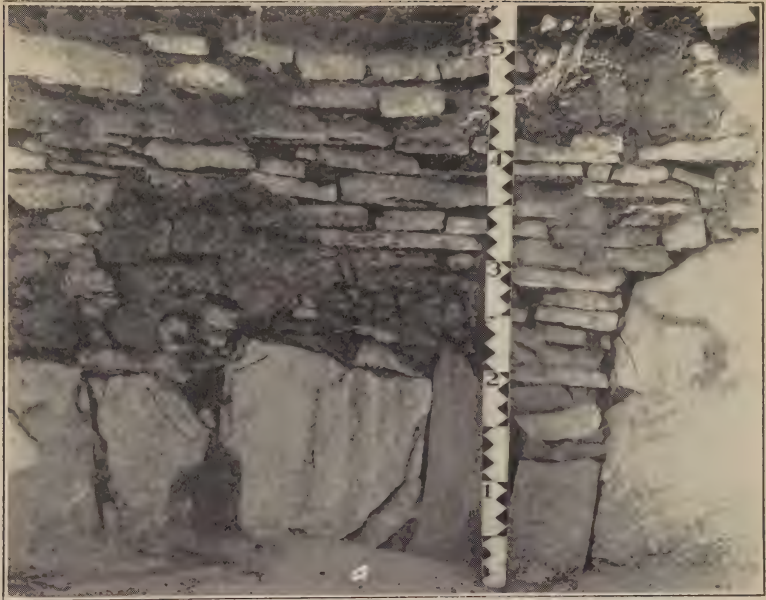
a. Masonry wall resting on slab foundation.

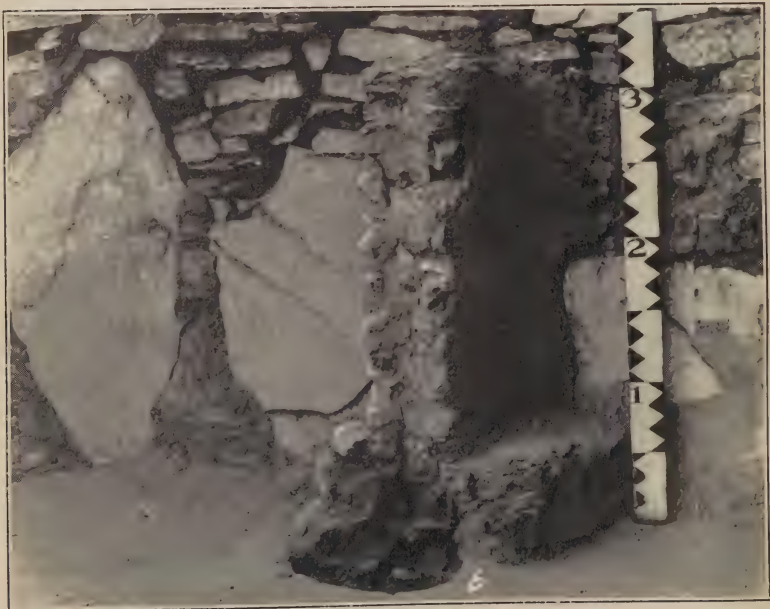
b. Pilaster in structure 2.

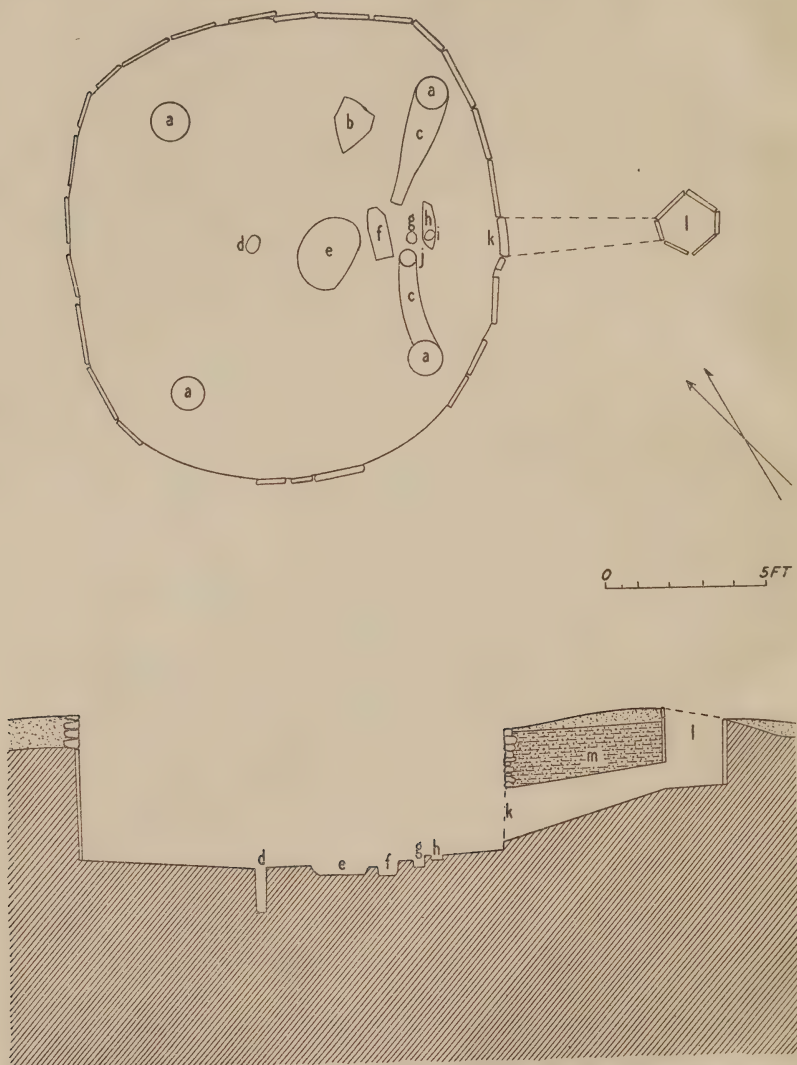
FIGURE 5.—Structure 2a. *a*, holes for main support posts; *b*, stone embedded in floor; *c*, adobe ridges forming compartment; *d*, sipapu; *e*, fire pit; *f*, ladder box; *g*, storage hole; *h*, groove in floor; *i*, pole mold; *j*, storage pit; *k*, ventilator opening; *l*, ventilator shaft; *m*, fill above ventilator passage.

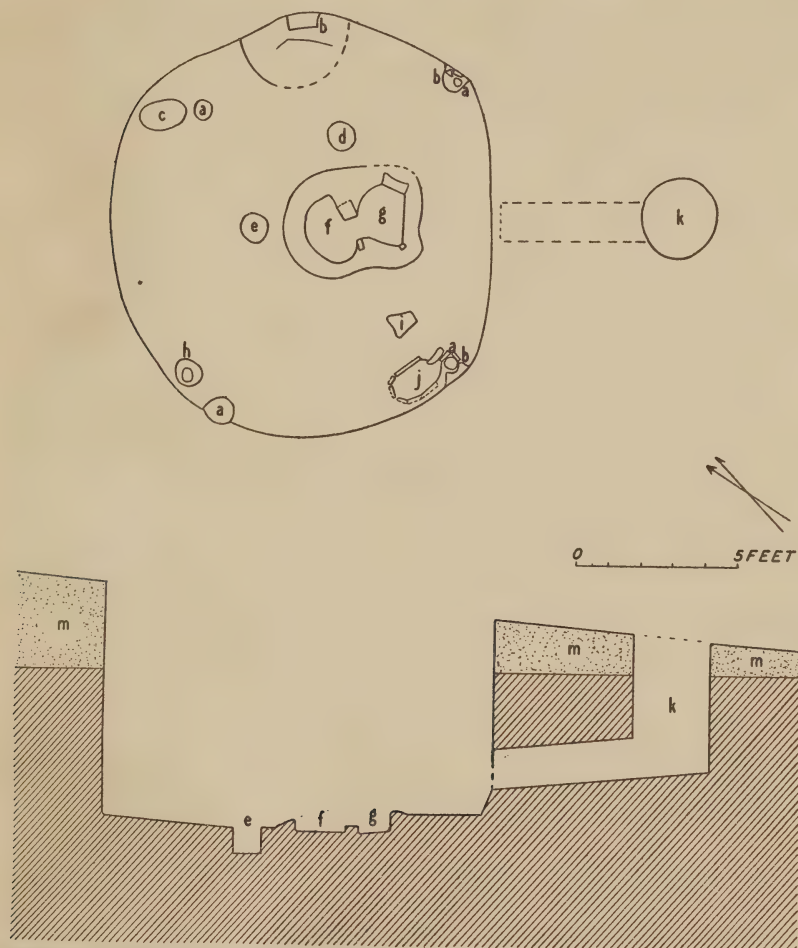
FIGURE 6.—Structure 3. *a*, support posts for superstructure; *b*, pilasters; *c*, storage basin; *d*, storage hole; *e*, sipapu; *f*, fire pit; *g*, ladder box; *h*, storage hole; *i*, stone embedded in floor; *j*, secondary fire pit; *k*, ventilator shaft; *m*, sand accumulation above old surface.

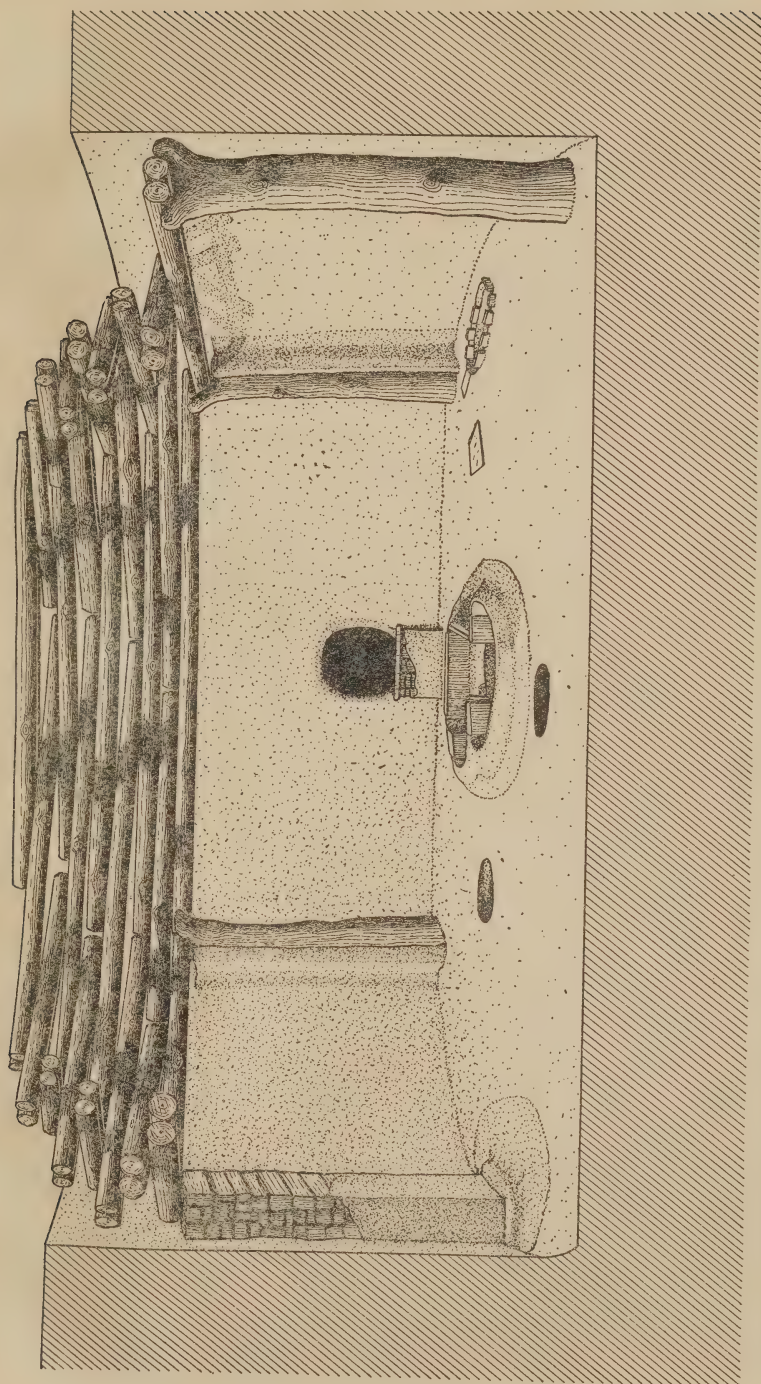
FIGURE 7.—Postulated reconstruction of cribbed roofing erected over pit of structure 3. One side removed to show method of laying timbers.

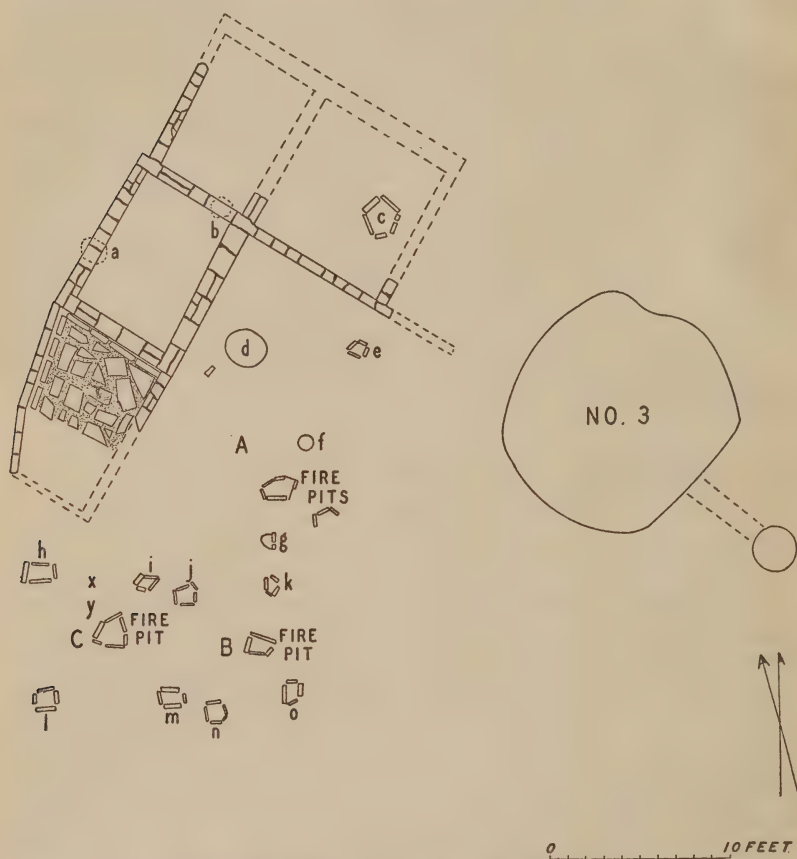
FIGURE 8.—Remains of surface building A. *a* and *b*, fire pits beneath foundations; *c*, fire pit in floor of room; *d*, opening into pit oven; *e*, *f*, and *g*, placements for portico posts; *h*, *i*, *j*, *k*, *l*, *m*, *n*, and *o*, placements for shelter posts; *x*, location of fragment of child's skull; *y*, location of black-on-white bowl.

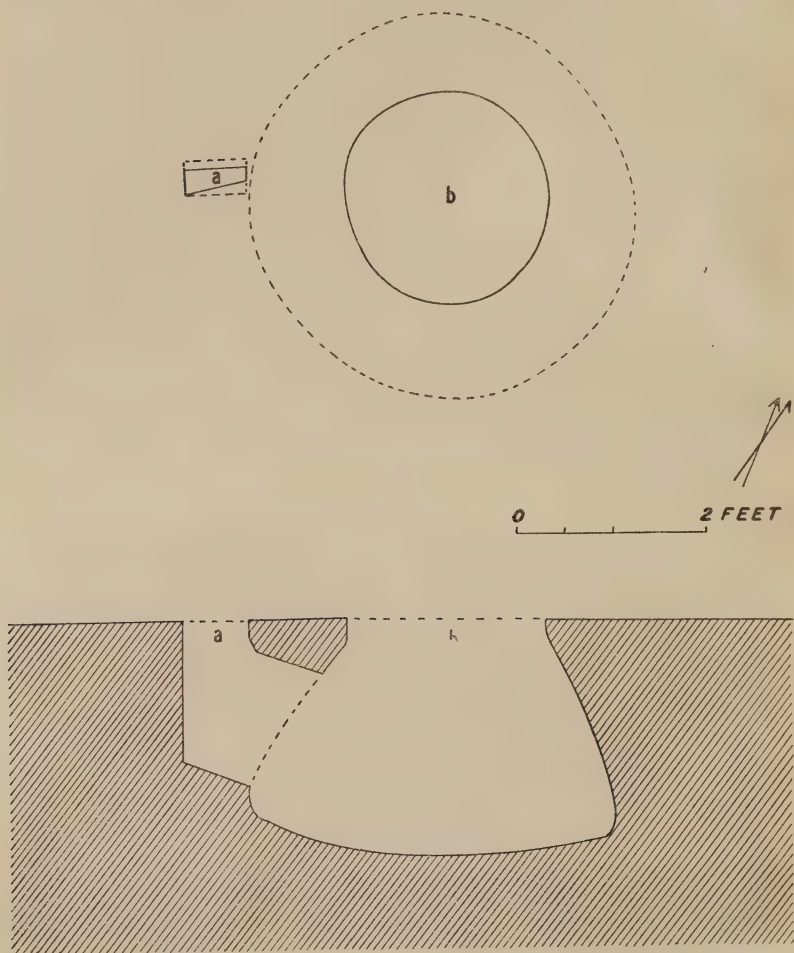
FIGURE 9.—Pit oven. *a*, flue; *b*, opening on ground level.

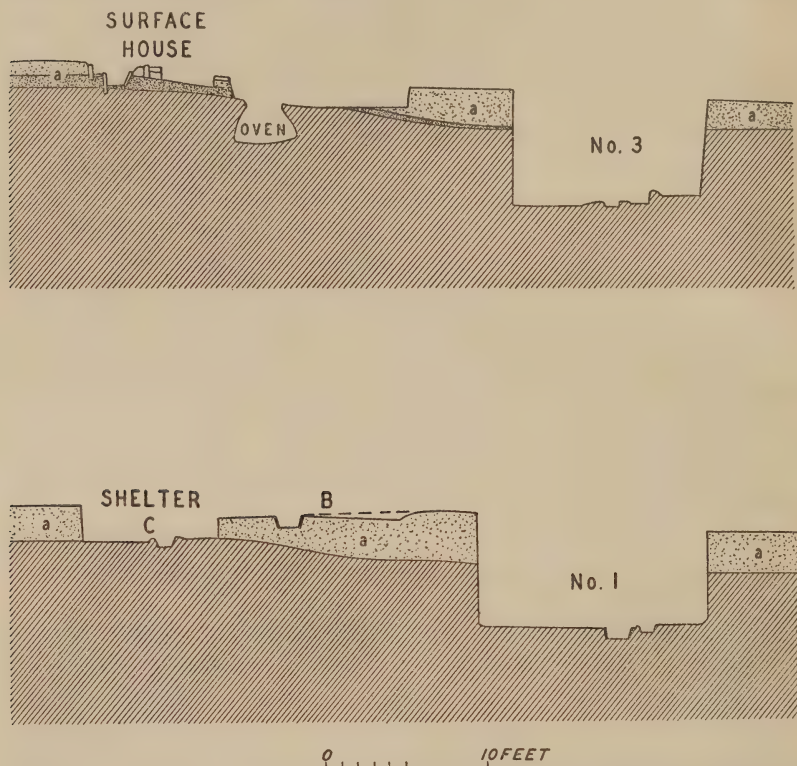
FIGURE 10.—Sections through surface remains A, pit oven and structure 3, shelter and structure 1. *a*, accumulation of sand above original surface of occupation.

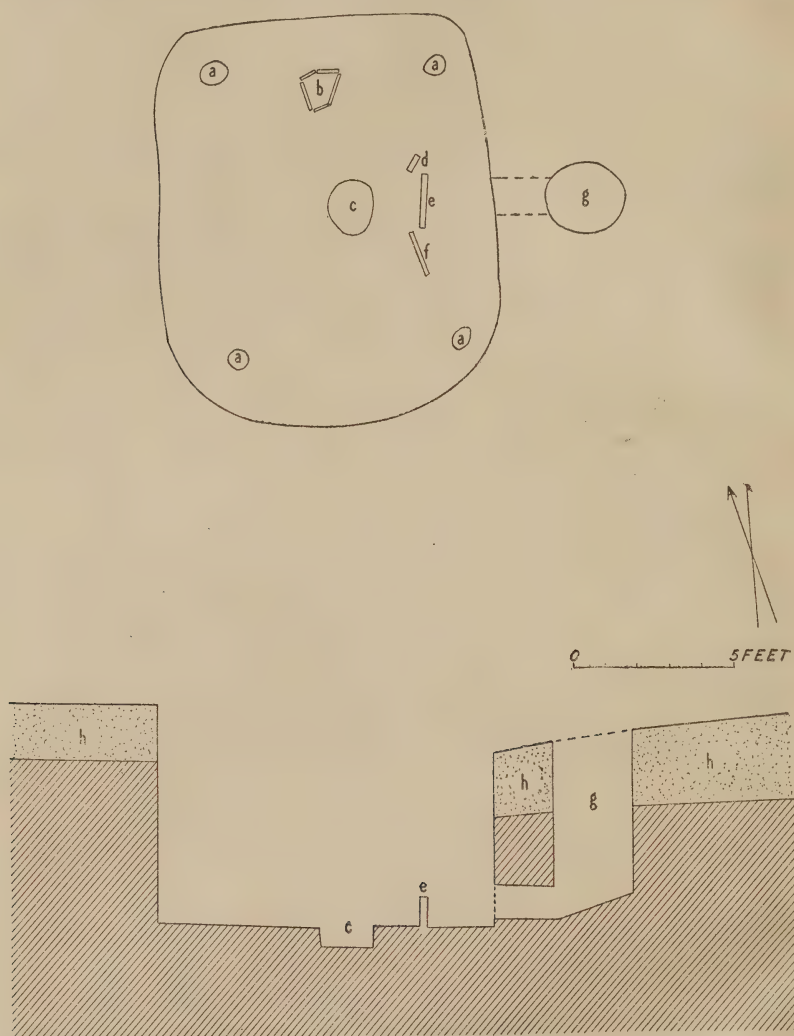
FIGURE 11.—Structure 4. *a*, holes for main support posts; *b*, storage box in floor; *c*, fire pit; *d*, standing stone; *e*, deflector; *f*, standing stone; *g*, ventilator shaft; *h*, sand accumulation above original surface.

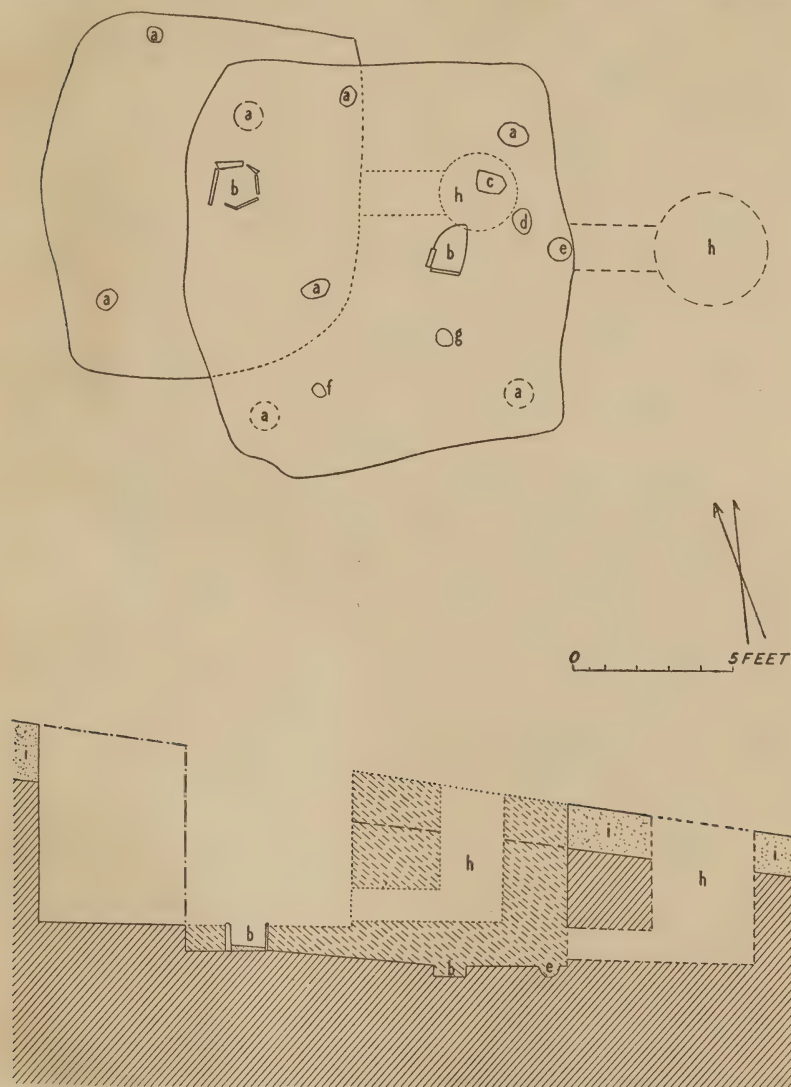
FIGURE 12.—Structures 5a and 5b. *a*, holes for main superstructure supports; *b*, fire pits; *c*, stone embedded in floor; *d*, basin in floor; *e*, hole in floor; *f* and *g*, storage holes; *h*, ventilator shaft; *i*, sand accumulation above old surface.

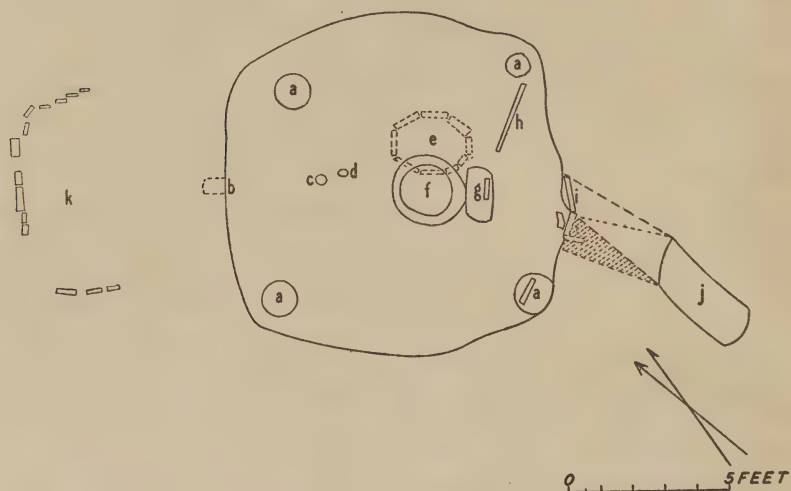
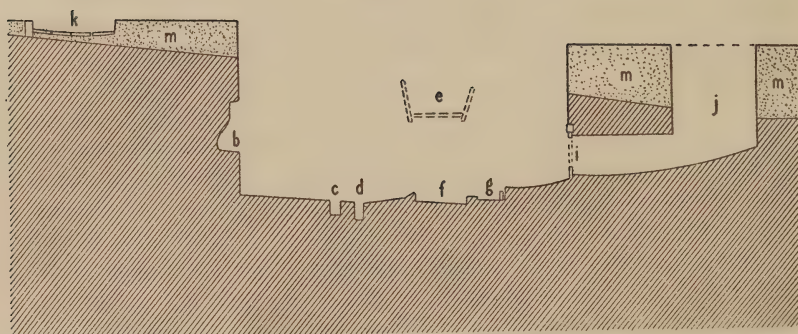
FIGURE 14.—Structure 6. *a*, holes for main roof supports; *b*, placement for roof brace; *c*, storage hole; *d*, sipapu; *e*, fire pit in fill; *f*, fire pit for 6; *g*, ladder pit; *h*, stone forming bin; *i*, ventilator stone; *j*, ventilator shaft; *k*, remains of granary; *m*, sand accumulation above old surface.

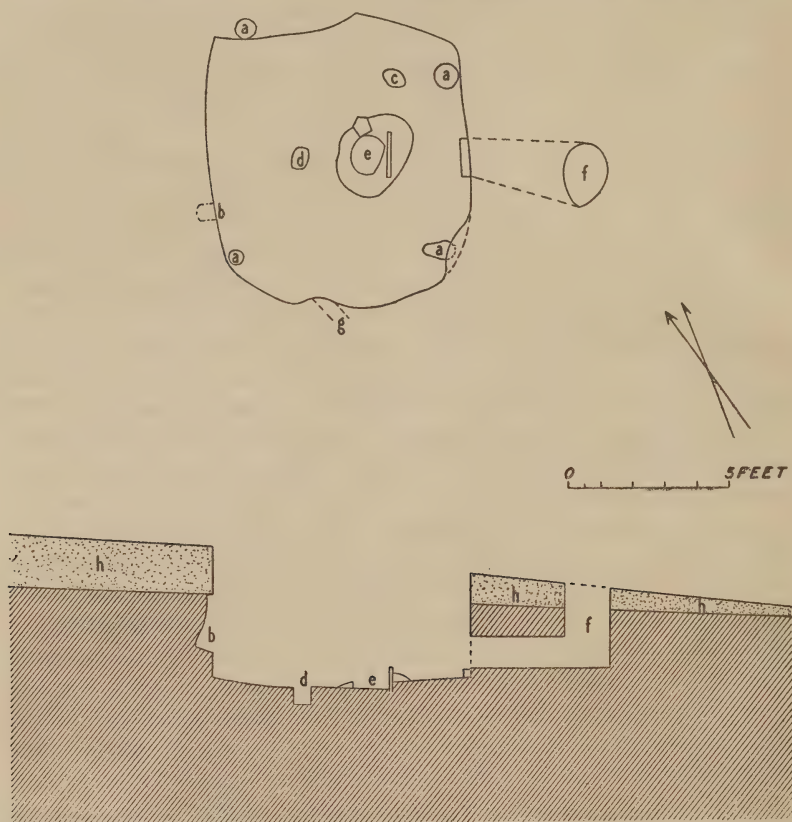
FIGURE 15.—Structure 7. *a*, holes for main support posts; *b*, placement for brace; *c*, storage hole; *d*, sipapu; *e*, fire pit; *f*, ventilator shaft; *g*, opening into 8; *h*, accumulation above original surface.

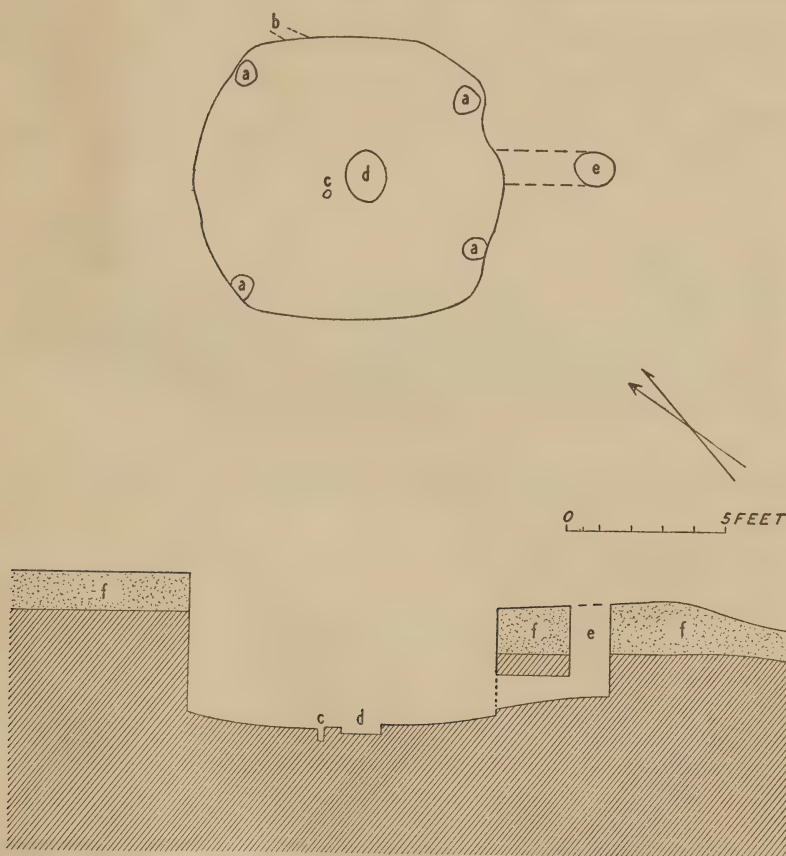
FIGURE 16.—Structure 8. *a*, holes for main supports; *b*, opening into 7; *c*, sipapu; *d*, fire pit; *e*, ventilator shaft; *f*, recent accumulation of sand above original surface.

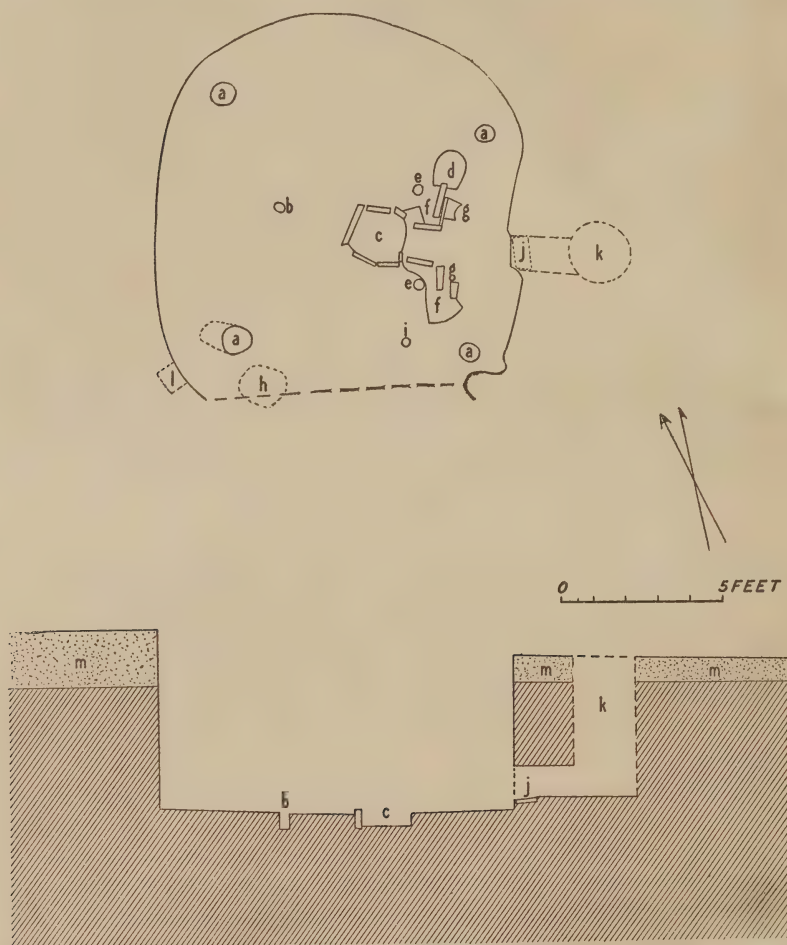
FIGURE 18.—Structure 9. *a*, holes for main support posts; *b*, sipapu; *c*, fire pit; *d*, fallen stone from compartment wall; *e*, holes for small poles; *f*, adobe plaster placement for compartment wall slabs; *g*, stones in compartment wall; *h*, location of support post for superstructure over 10; *i*, storage hole; *j*, ventilator opening and sill; *k*, ventilator shaft; *l*, placement for roof brace; *m*, sand accumulation above old surface.

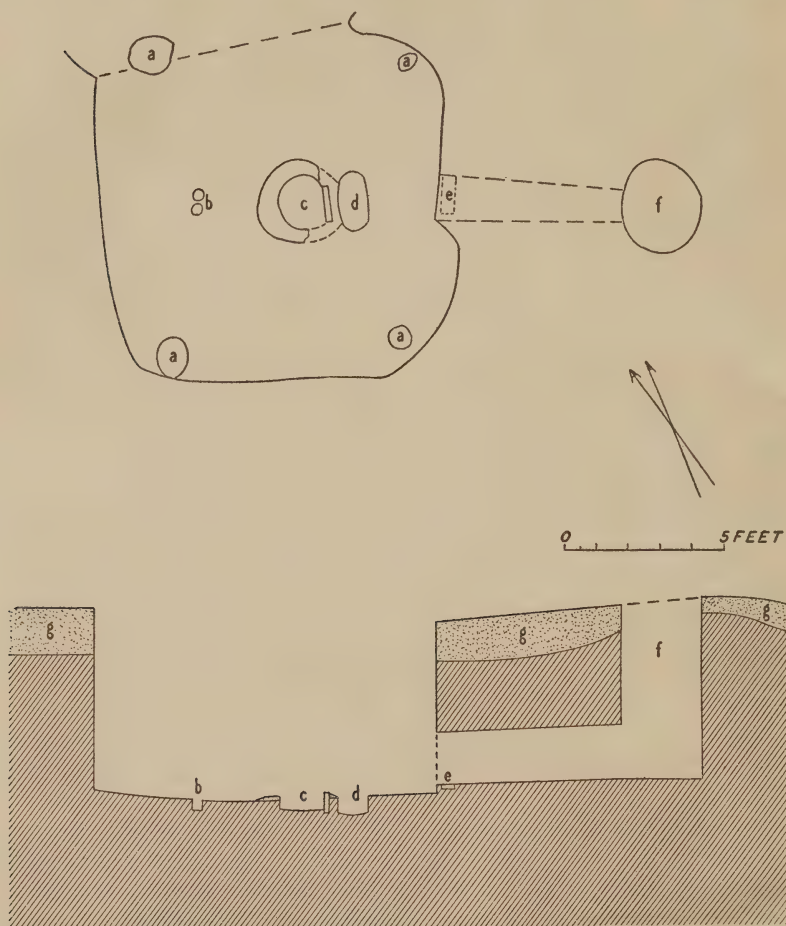
FIGURE 19.—Structure 10. *a*, holes for support posts; *b*, sipapu; *c*, fire pit; *d*, ladder box; *e*, ventilator opening; *f*, ventilator shaft; *g*, accumulation of sand above original surface.

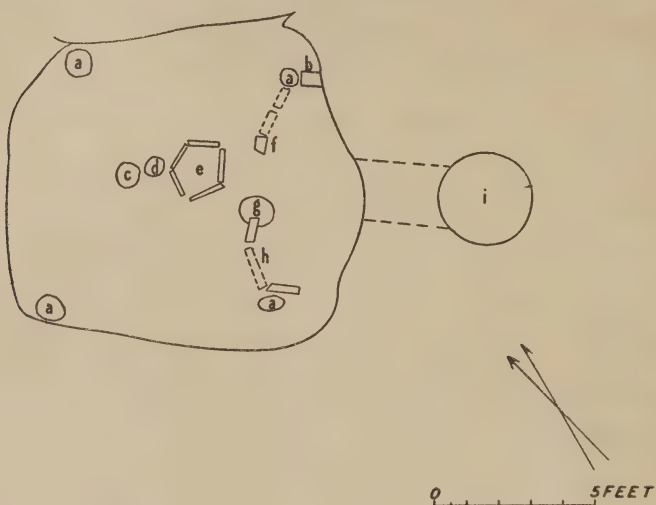
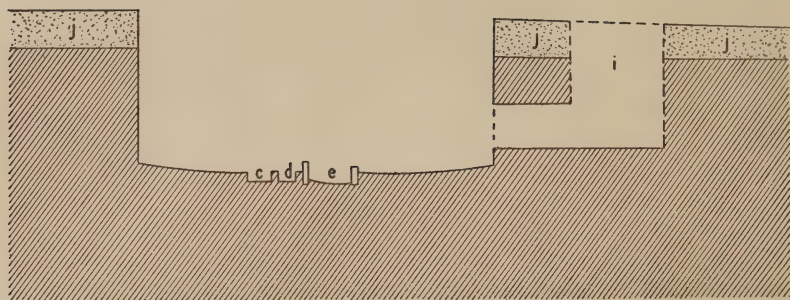
FIGURE 20.—Structure 11. *a*, holes for main support posts; *b*, stone in compartment wall; *c* and *d*, holes in floor in position of sipapu; *e*, fire pit; *f*, stone in compartment wall; *g*, storage basin; *h*, stone mold; *i*, ventilator shaft; *j*, accumulation of sand above original surface.

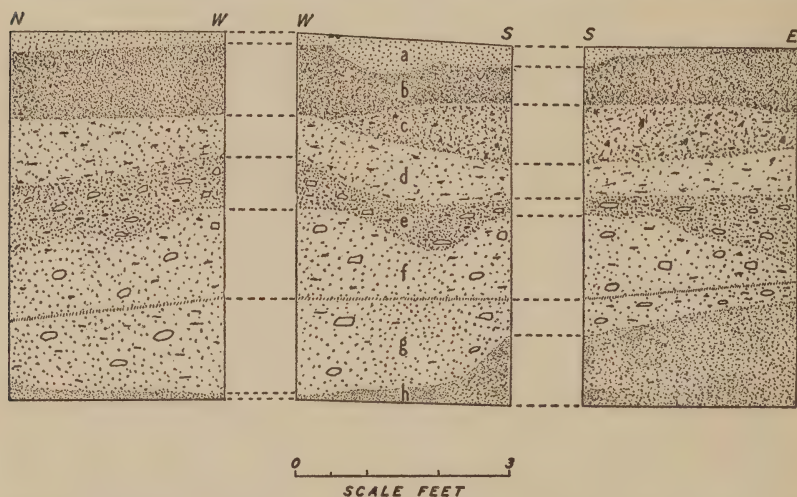
FIGURE 22.—Test pillar from fill in structure 10. N, W, S, and E, indicate north, west, south, and east corners.

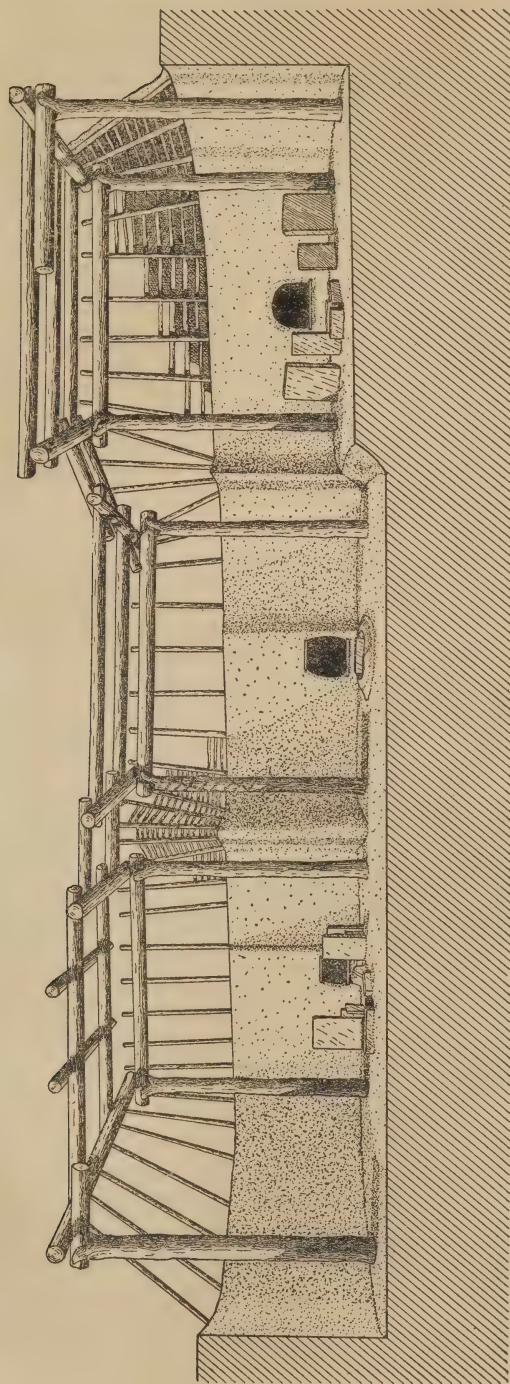
FIGURE 23.—Postulated reconstruction of timber arrangement in superstructure erected over pits 9, 10, and 11. Some of main support posts omitted at front of drawing to show construction more clearly.

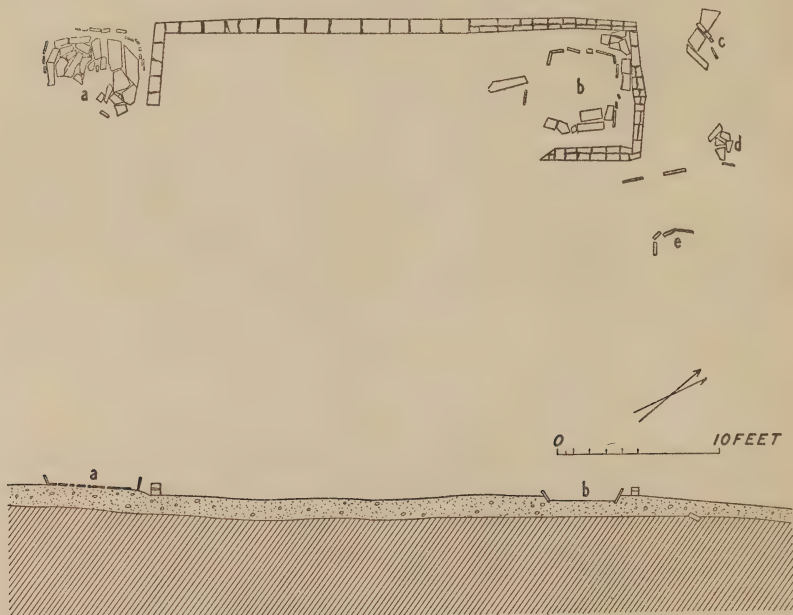
FIGURE 24.—Surface remains B in first group. Granary pits at *a*, *b*, *c*, and *d*; exterior fire pit at *e*.

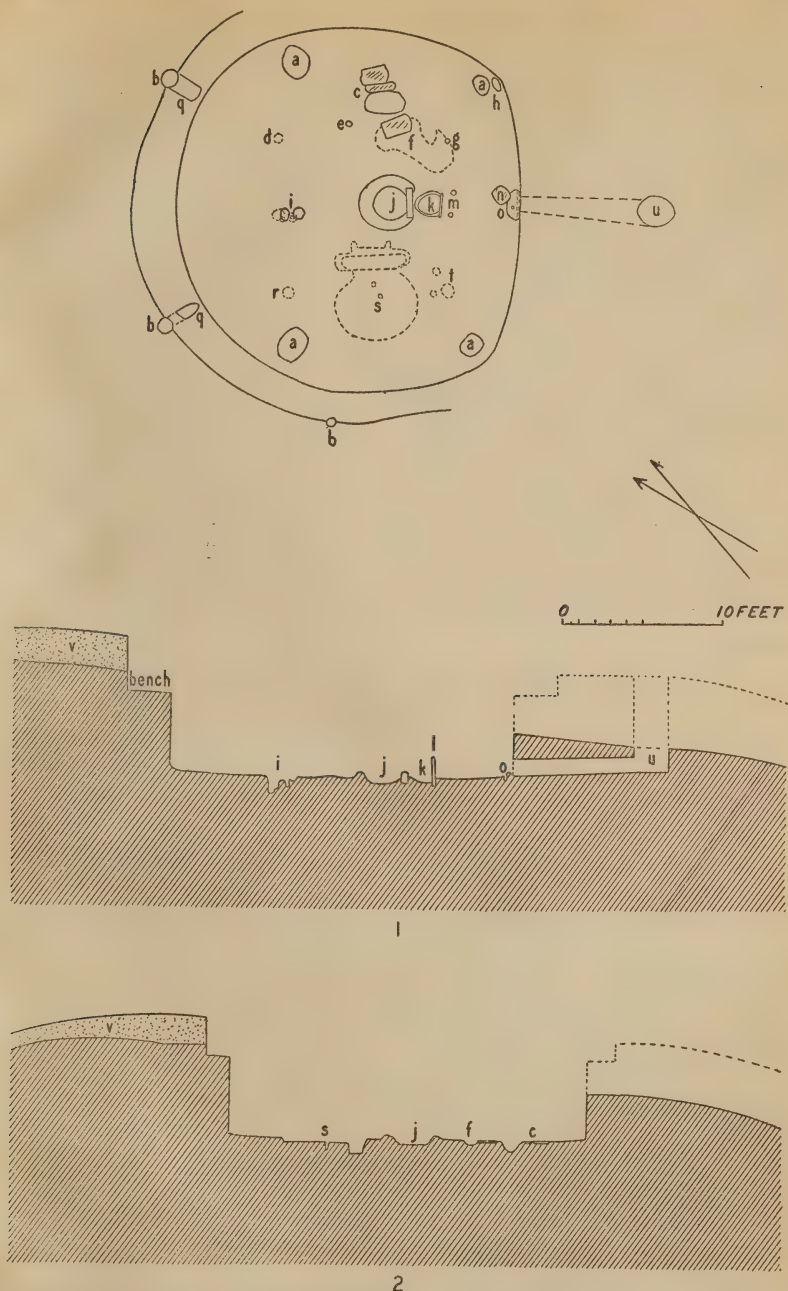
FIGURE 26.—Structure 12. *a*, holes for main support posts; *b*, secondary supports at back of bench; *c*, paving on floor; *d*, plastered-over hole in floor; *e*, storage hole; *f*, plastered-over basin; *g*, storage hole in floor; *h*, storage basin; *i*, sipapu holes; *j*, fire pit; *k*, ash pit; *l*, deflector; *m*, ends of ladder poles; *n*, cover stone for ventilator; *o*, shelf for cover stone and hole for small post to hold stone; *q*, plaster ridges on bench; *r*, plastered over hole; *s*, plastered over basin suggestive of subfloor kiva vault; *t*, plastered-over holes; *u*, ventilator shaft; *v*, sand accumulation.

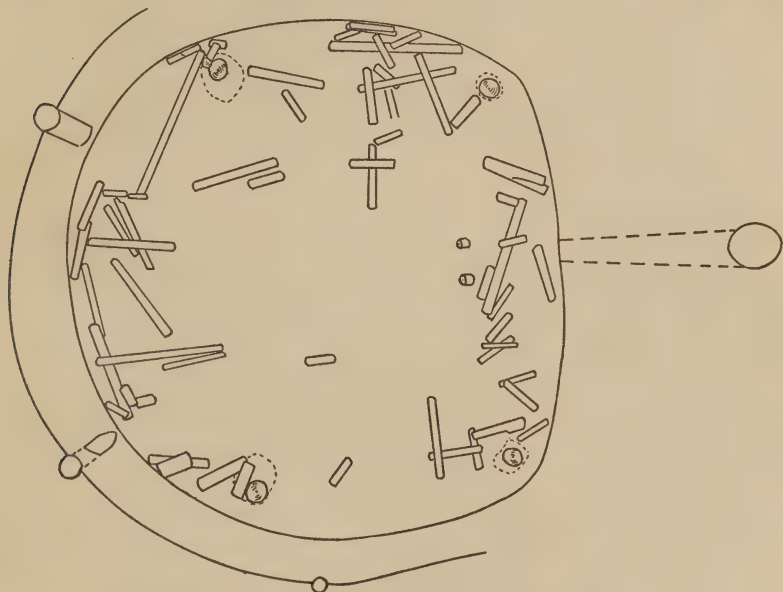
FIGURE 27.—Positions of burned timbers on floor of structure 12.

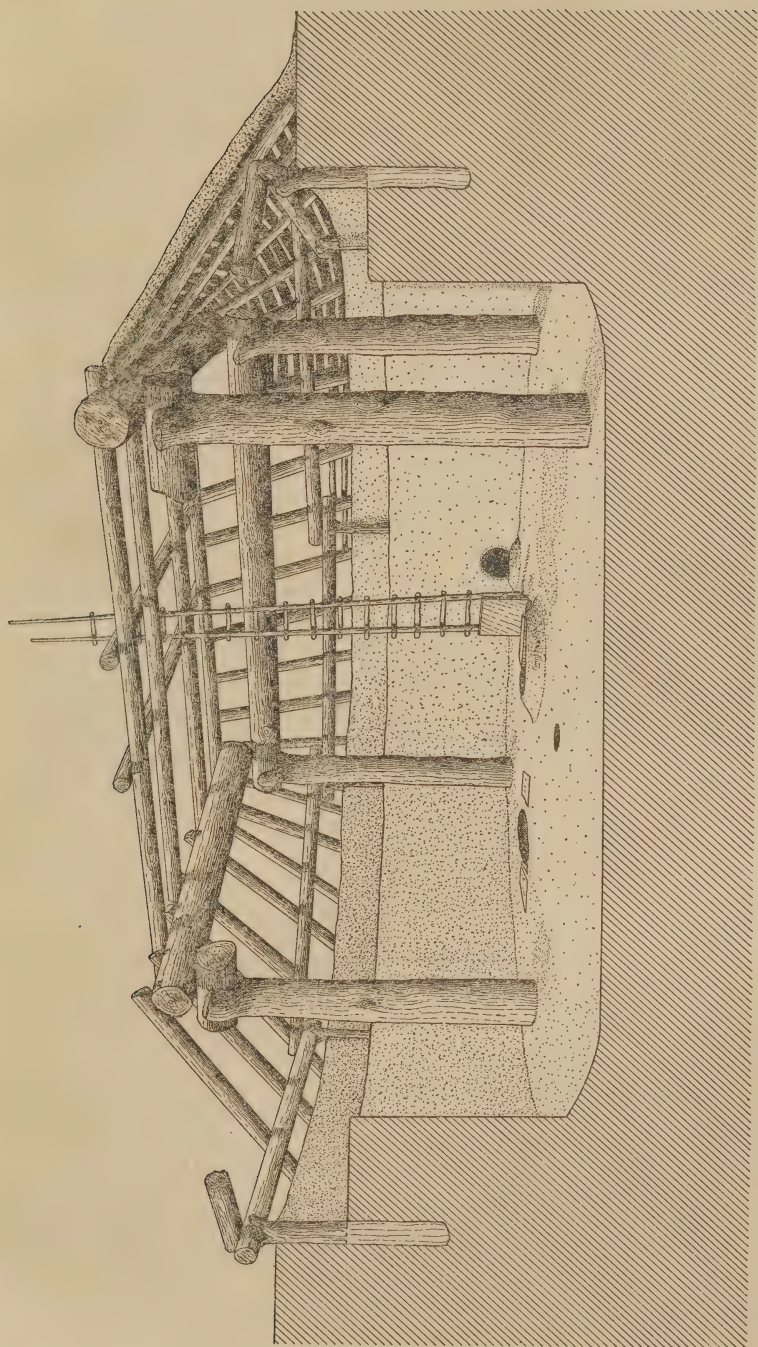
FIGURE 28.—Postulated reconstruction of superstructure erected over structure 12. Some of front timbers omitted from drawing so as not to complicate the diagram.

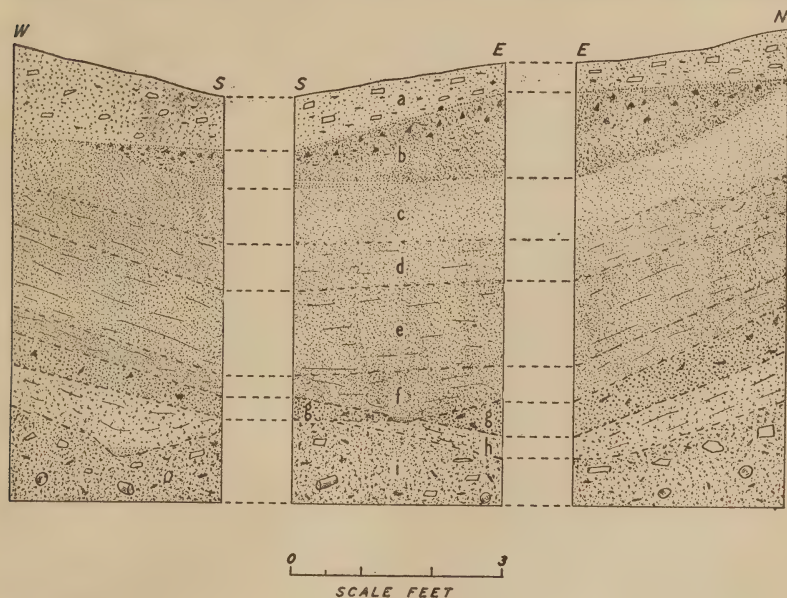
FIGURE 29.—Pillar left from fill in structure 12. E, W, N, and S indicate east, west, north, and south corners.

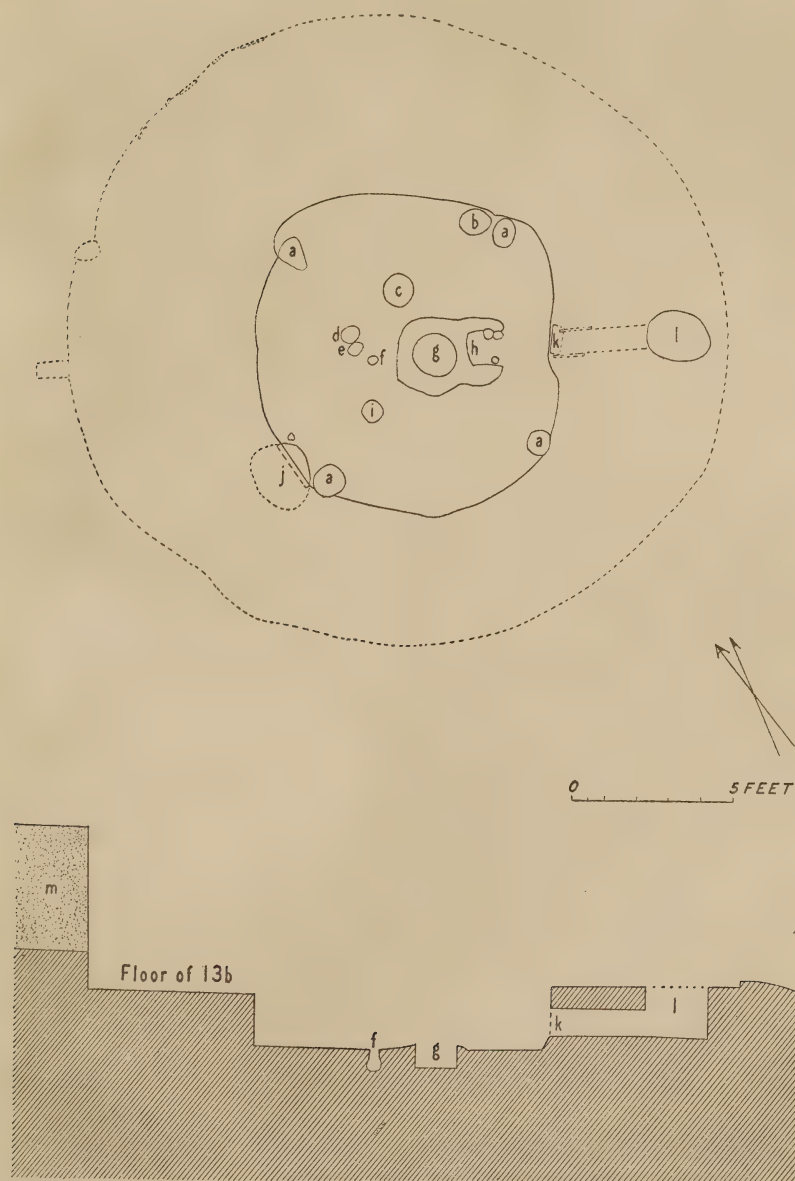
FIGURE 30.—Structure 13a. *a*, holes for superstructure support posts; *b*, *c*, *d*, and *e*, storage holes; *f*, sipapu; *g*, fire pit; *h*, ladder box; *i*, storage basin; *j*, storage pocket in wall; *k*, ventilator opening in chamber; *l*, ventilator shaft; *m*, accumulated sand. Dotted lines indicate position of 13b.
